Damage Limiting Construction – Part 1 The Event

Damage Limiting Construction- Part 1. HCI Systems, Inc.

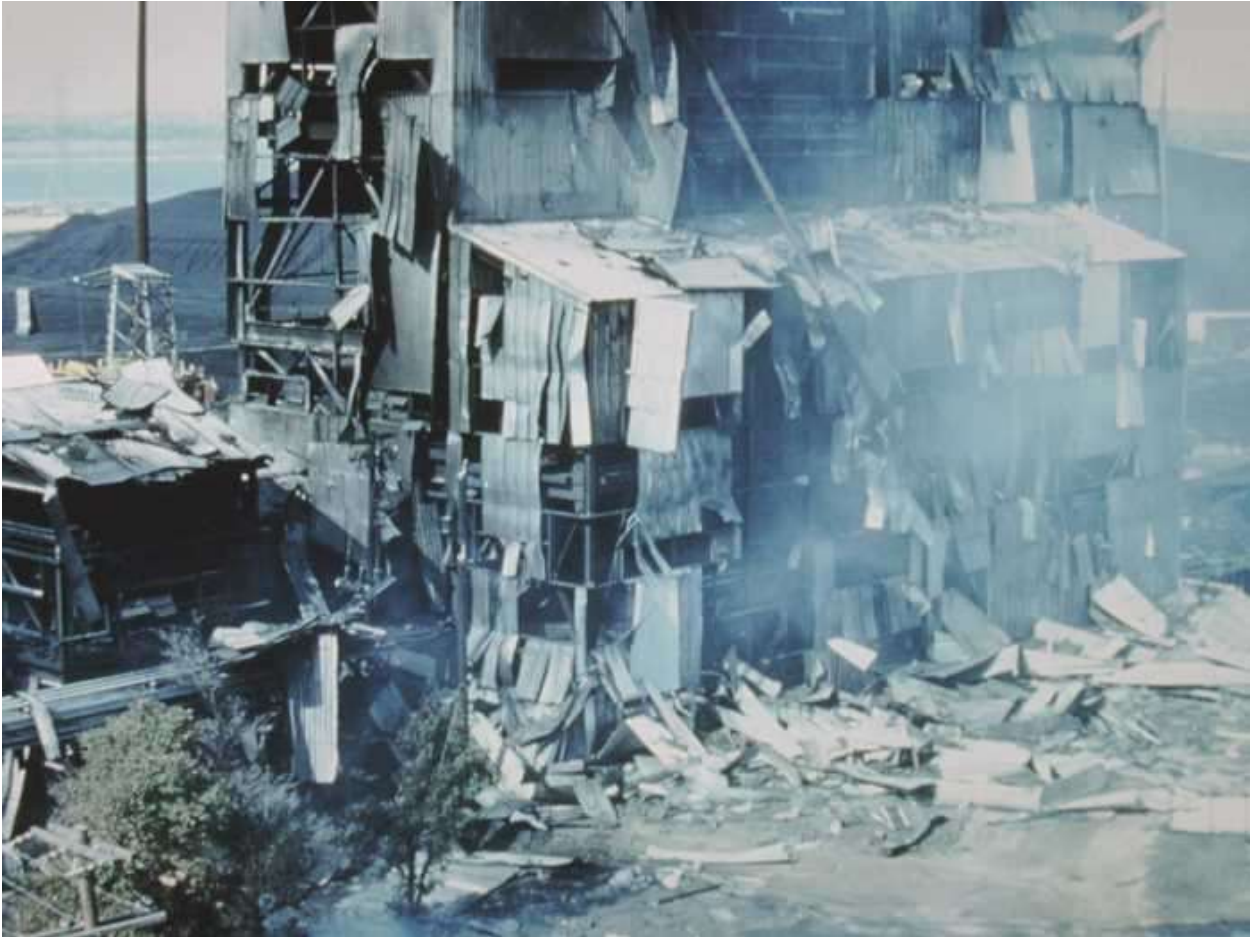
This photo does not depict a recent event. So no need to try to "Google" it. It was one of my experiences early on in my career. Some called it the Humpty Dumpty project. I have used this photo in many of my Damage Limiting Construction (DLC) seminars. It's an eye opener. It is **not** an example of how to design a structure for overpressure. Although, in this example, the combustible was coal dust, it is equally applicable for any dust that is combustible. This is the first article in a multi-part series that will discuss methods to reduce the risk of such an event including the technique of damage limiting construction.

At first glance the photo appears to suggest the event was limited to the building involved. But, as future articles will show, the event propagated throughout the plant. So what happened here? Well, apart from the presence of combustible dust above the LEL and an ignition source, the structure was not designed to fail in a predetermined way. The confinement of the fire ball by the siding resulted in an increasing internal pressure that

eventually overcame the siding fasteners. Just about all of them. The fire ball under that initial pressure made its way to other parts of the plant shaking structures as it propagated releasing additional dust to fuel the event.
